# How clean must rebar be?

**Most specifications require reinforcement to be free of deleterious materials. But do common construction contaminants have a harmful effect on bond?**

BY BRUCE A. SUPRENT AND WARD R. MALISCH

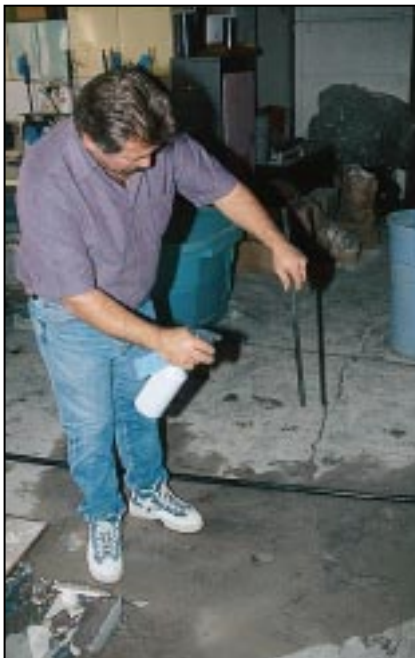
**Figure 1.** Form-release agent was sprayed on the rebar, covering 100% of the surface.

Grade-60, #4 deformed rebar were used. The form release and curing compound/bond breaker were sprayed on 100% of the rebar surface (Fig. 1) to duplicate the worst case of contaminant coverage possible during construction. The used motor oil was applied to the entire bar length with a rag. A cement paste was mixed and applied to various areas of the rebar (Fig. 2a). To produce rusted rebar, three bars were dipped in hydrochloric acid then stored in a moist curing room. Figure 2b shows the amount of rust on the bars.

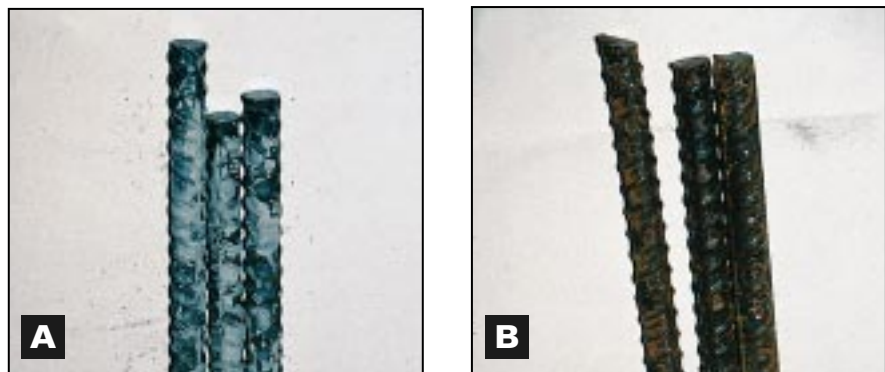
**Figure 2.** Amount of cement splatter (a) and rust (b) on the rebar tested.

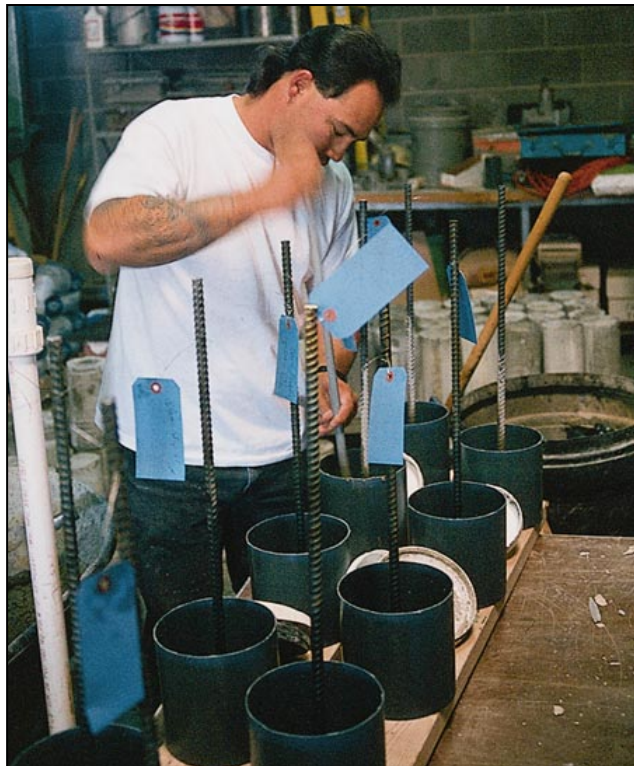
**Figure 3.** Pull-out specimens were cast in 6-inch-diameter, 6-inch-tall cylinder molds with a #4 rebar at least 24 inches long inserted at the center.

We constructed bond pull-out specimens with a 6-inch embedment depth by using the bottom halves of 6x12-inch plastic cylinder molds with a  $\frac{3}{8}$ -inch-diameter hole drilled through the bottom of each (Fig. 3). The molds, 27 in all, were placed on 2x6-inch boards that had been predrilled with  $\frac{3}{8}$ -inch-diameter,  $\frac{1}{2}$ -inch-deep holes. We inserted #4, Grade-60 deformed rebar at least 24 inches long in a vertical position, with  $\frac{1}{2}$  inch of the rebar protruding from the bottom of the cylinder mold into the hole in the 2x6. This

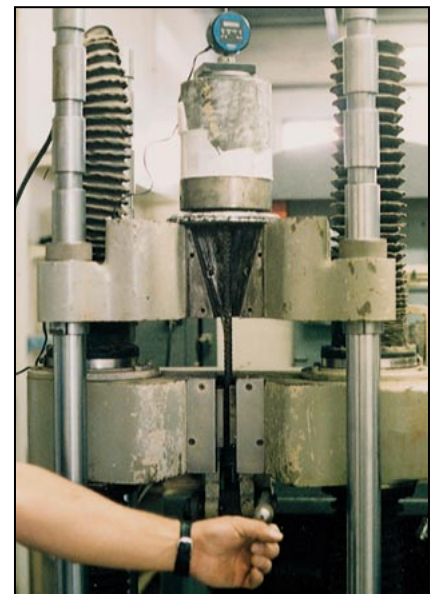
**Figure 4.** With the test specimen placed on a spherical bearing block on top of the testing machine, a tensile load was applied with serrated grips. An electronic digital indicator measured slip at the free end of the rebar.

Figure 4 shows a typical setup for a pull-out test. Test specimens were placed on a spherical bearing block on top of the testing machine. serrated grips were then connected to the rebar to allow the machine to load the bar in tension. A 60,000 pound Tinius-Olsen universal tension/compression frame was used to apply the load to the rebar at about 200 pounds per second. Technicians measured slip of the free end of the rebar with a Fowler 1/10,000 electronic digital indicator.

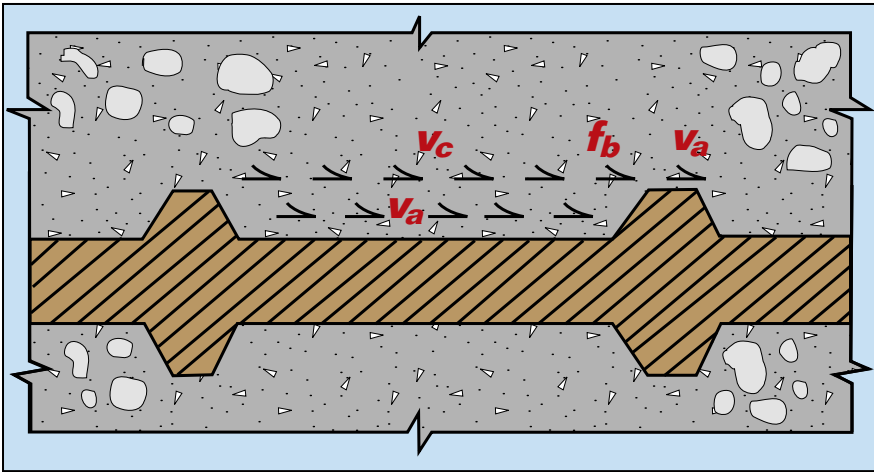
**Figure 5.** Applied tensile forces in the rebar are resisted by adhesion ( $v_a$ ) along the bar surface, bearing ( $f_b$ ) against the deformation face and shear in the concrete ( $v_c$ ) between adjacent deformations. For rebar coated with contaminants, adhesion was reduced, but the bar still broke because of resistance provided by bearing and concrete shear strength.

the deformations, however, no shiny surface was visible, indicating that concrete bearing against the rebar deformations during loading removed the contaminant by friction. We believe the greater initial slip of rebar covered with the contaminants was due to loss of adhesion along the smooth part of the bar between the deformations. As shown in Figure 5, after the initial slip, the load was resisted by bearing of the deformations on the concrete and the shear strength of the concrete between the deformations (Ref. 5).
